**Sebert Trillingstechniek B.V.**

Report: M25.001-P25.001 One Display Solution  
Date 14 November 2025

## MIL-STD 810/AECTP 400 Random Vibration and Terminal Peak Sawtooth Shock Tests on a PSM-P86RV1

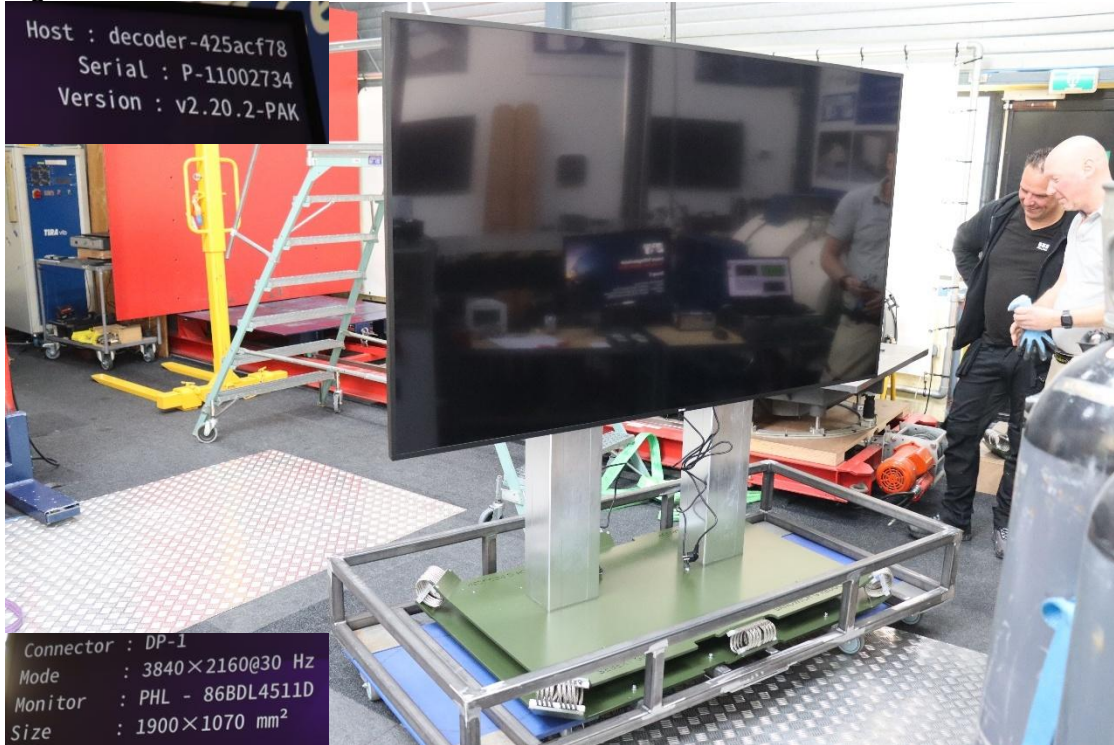
Figure 1: Test item

One test item has been used for the tests, see Table 1 for the details of the test item. The test item which was delivered on 17 March 2025 was checked before starting the test for visual damage and no deviations were found.

Product name*	PSM-P86RV1
Product number / SN*	PSM-P86RV1 / ODSPSM2025001
Monitor model / SN*	PHL-86BDL4511D / AU0A2351003926
Decoder model / SN*	VUWALL PAK40-3 / P-11002734
Actuators model / SN*	OKIN-MEGAMAT20MODIFIED / 10032025
Dimensions [LxWxH]	196 x 181 x 96 cm (including test frame)
Weight	264 kg (including test frame)
Figure	#1 #2

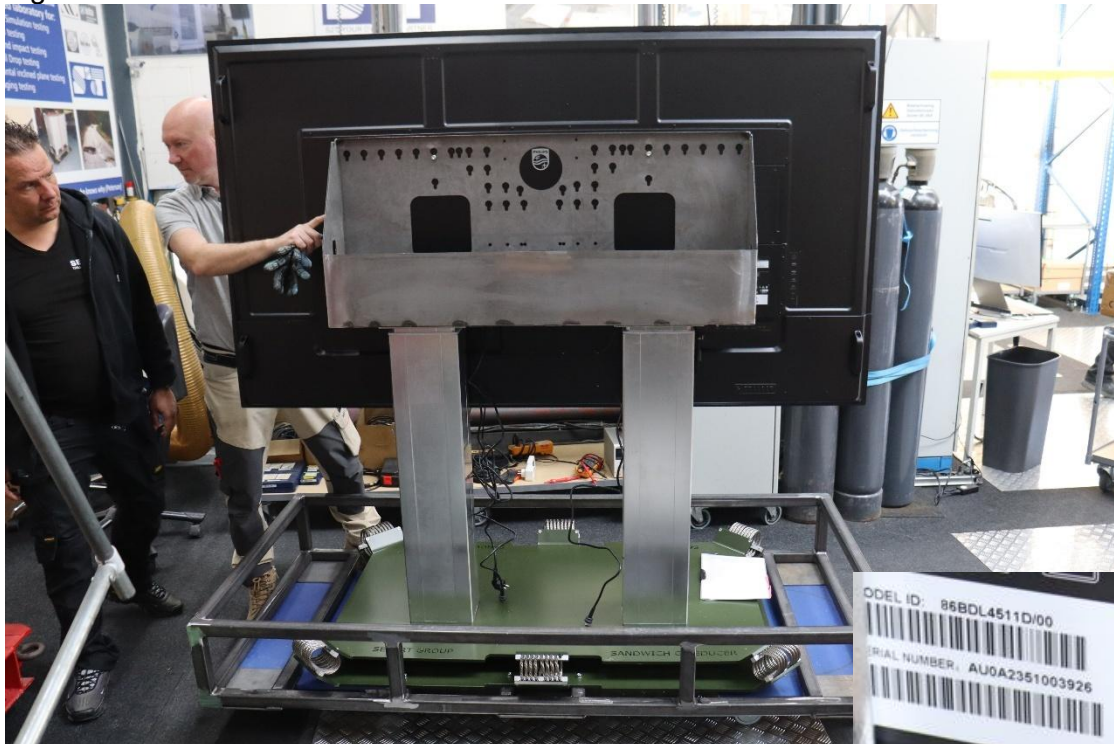
Figure 2: Test item

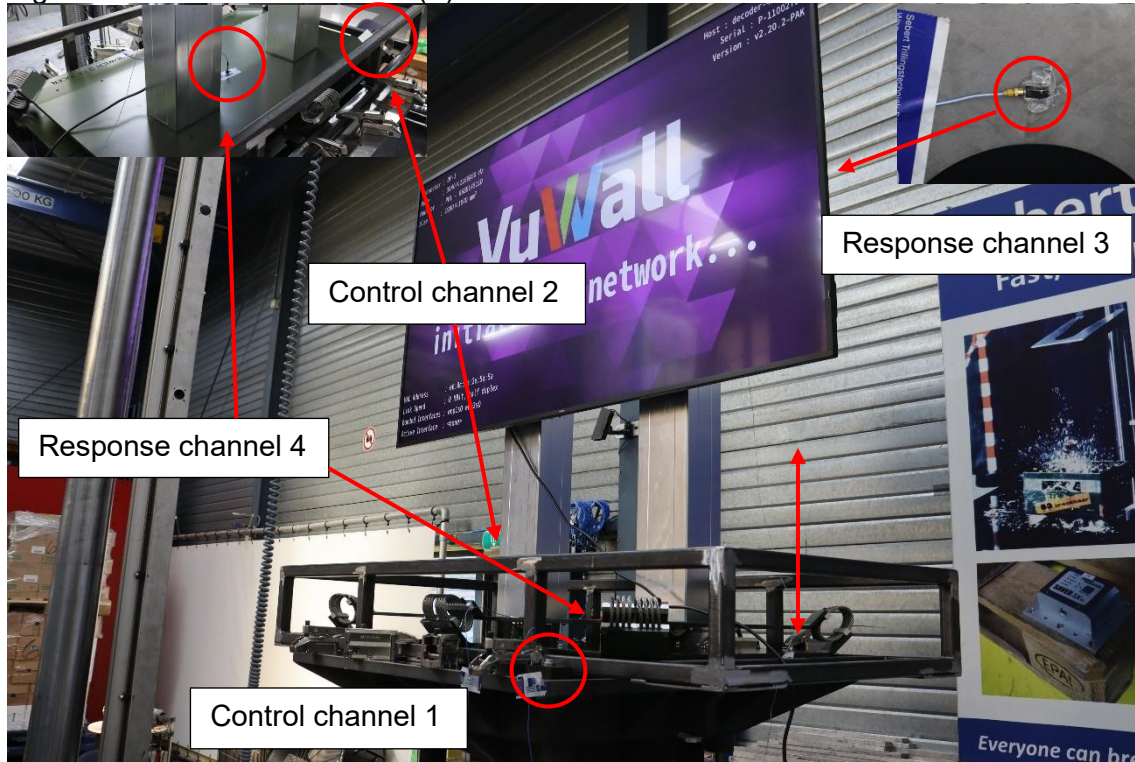
Figure 3: Test direction vertical (Z) and accelerometer location

For tests A to D, the test item was fixed to the test surface by clamping the flat metal base of the shock damper base inside a transport frame directly onto the test surface. Transport wheels were removed to improve the transfer of test energy through the test item and create a worst case transportation scenario. The test item was mounted on the vibration table in the normal orientation with respect to the vertical. The tests were carried out in three mutually perpendicular directions, see Figure #3 for the vertical (Z) direction, see Figure #4 for the horizontal transversal (X) direction and see Figure #5 for the horizontal longitudinal (Y) direction.

Test item	Direction		Figure
1	XYZ	Classified – Confidential NATO	#3 - #5
1	XYZ		#3 - #5
1	XYZ		#3 - #5
1	XYZ		#3 - #5

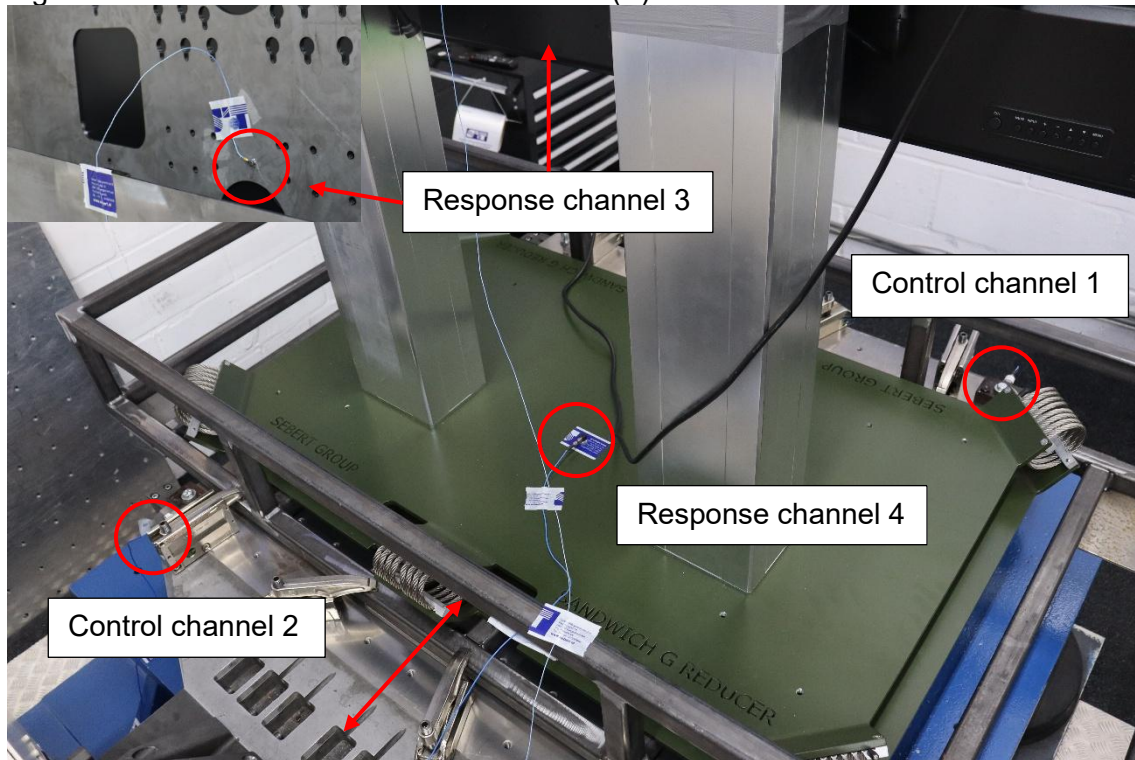
Figure 4: Test direction horizontal transversal (X) and accelerometer location

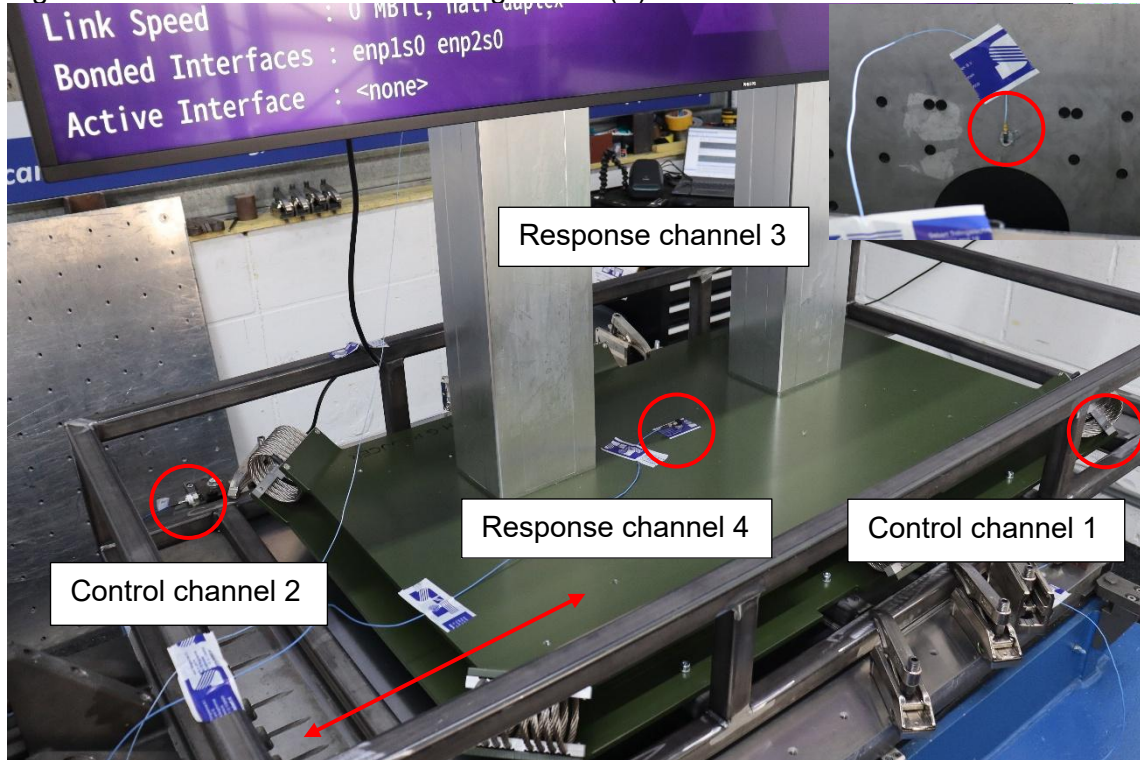
Figure 5: Test direction horizontal longitudinal (Y) and accelerometer location

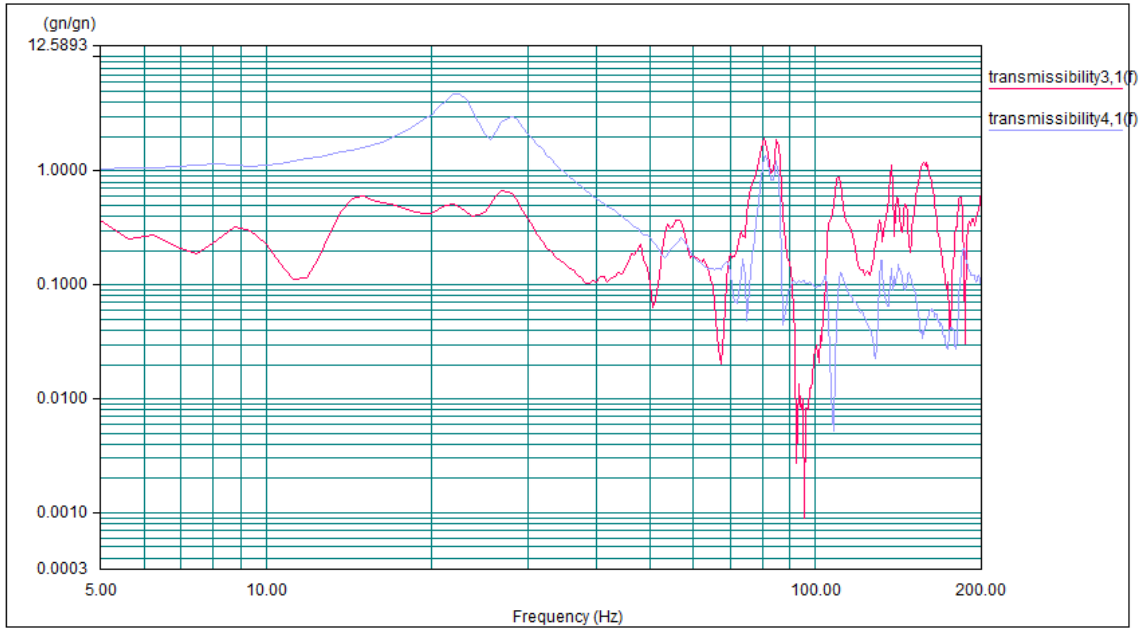
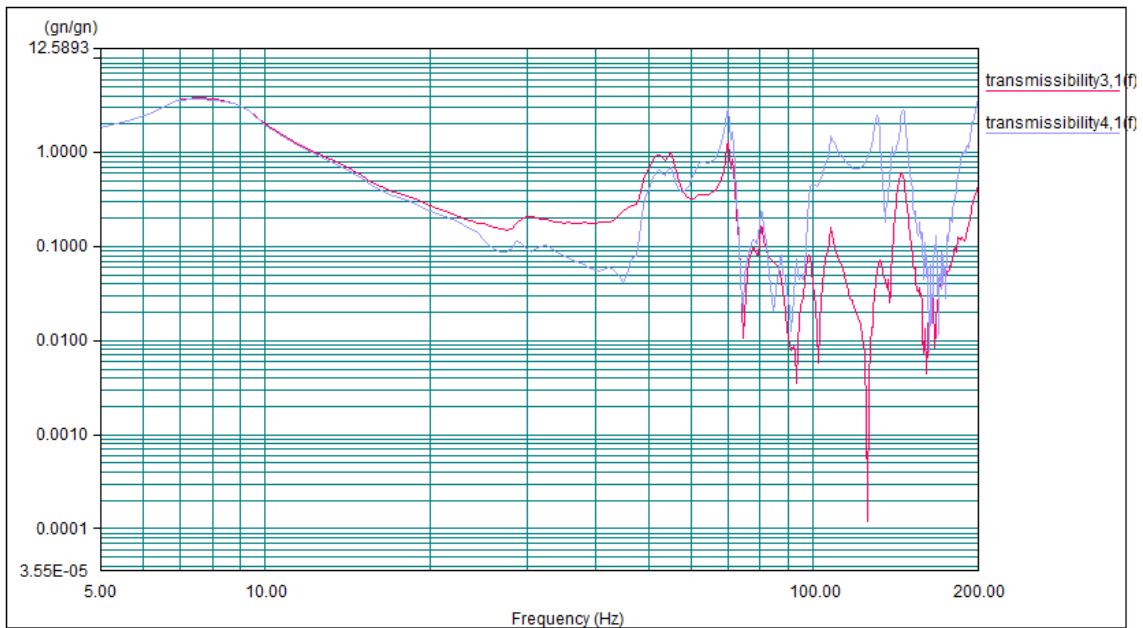
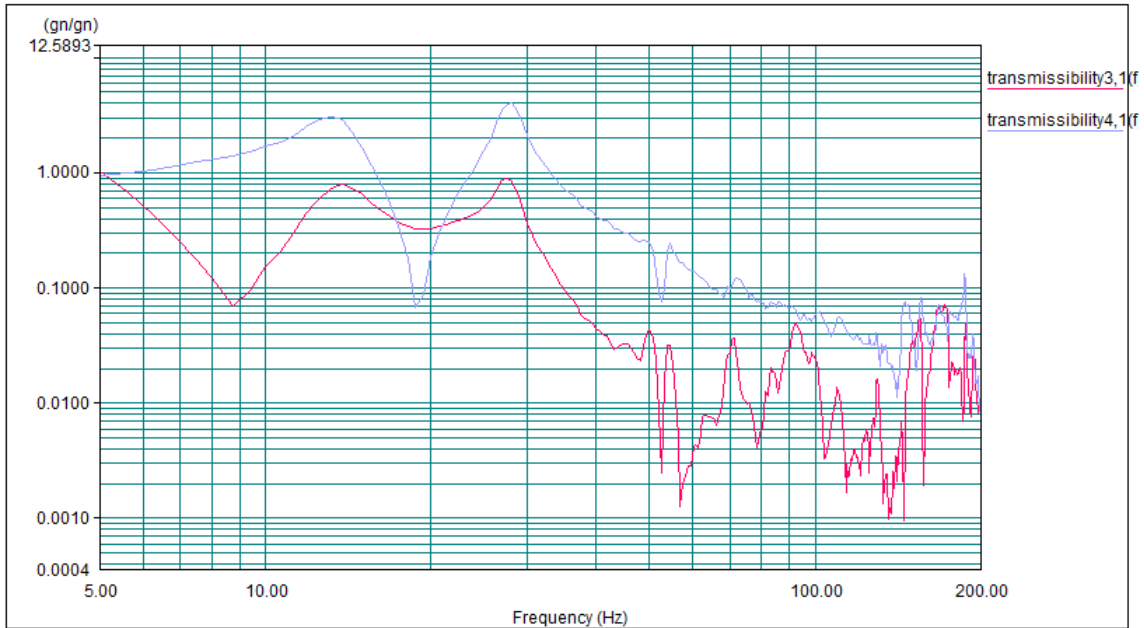
Figure 7: Test A Sea - Transmissibility measurement, input 3 and 4 transversal X

Figure 8: Test A Sea - Transmissibility measurement, input 3 and 4 vertical Z

Figure 9: Test A Sea - Transmissibility measurement, input 3 and 4 longitudinal Y

One test item has been used for the random vibration test which was carried out in the three mutually perpendicular directions, see Table 6 for the result summary. See Figure #6 for a typical vibration plot and Figure #7 to #9 for the transmissibility measurements of accelerometer response channels 3 and 4. The natural frequency ( $F_n$ ) of the test item was identified at 8-9Hz, damping started to occur at 12Hz. No visual damage or functional errors were found on the test item after the complete test sequence.

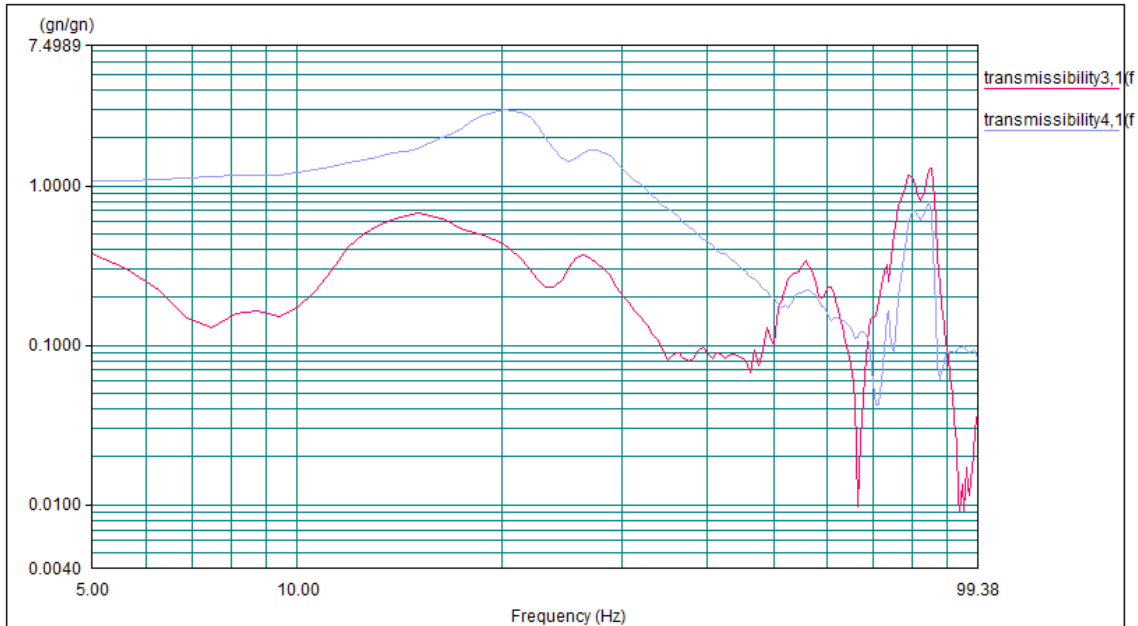
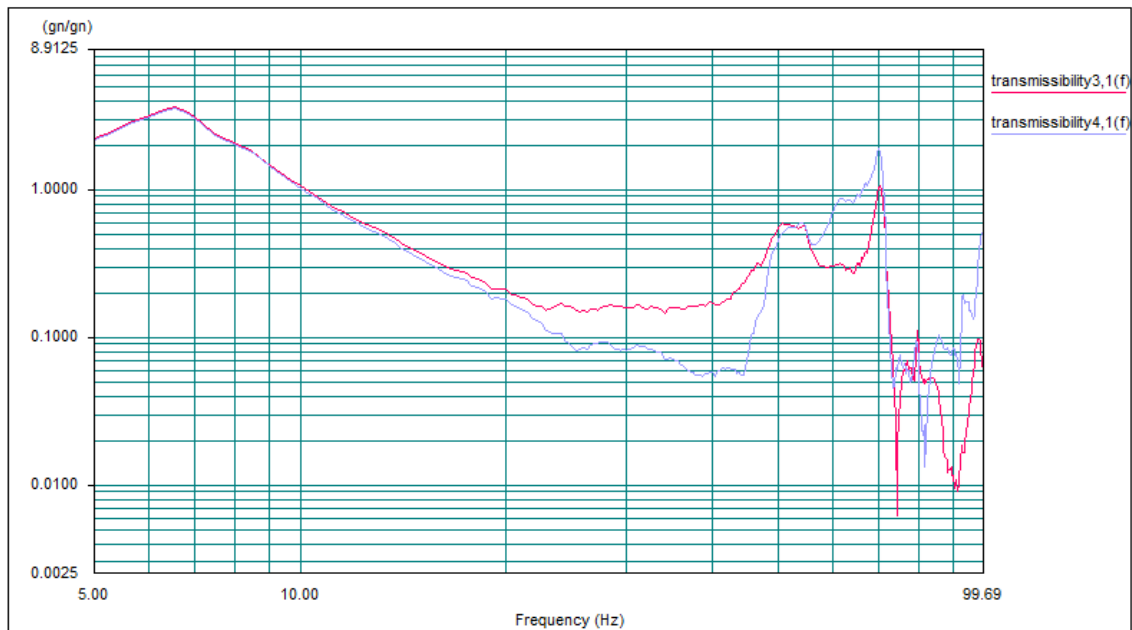
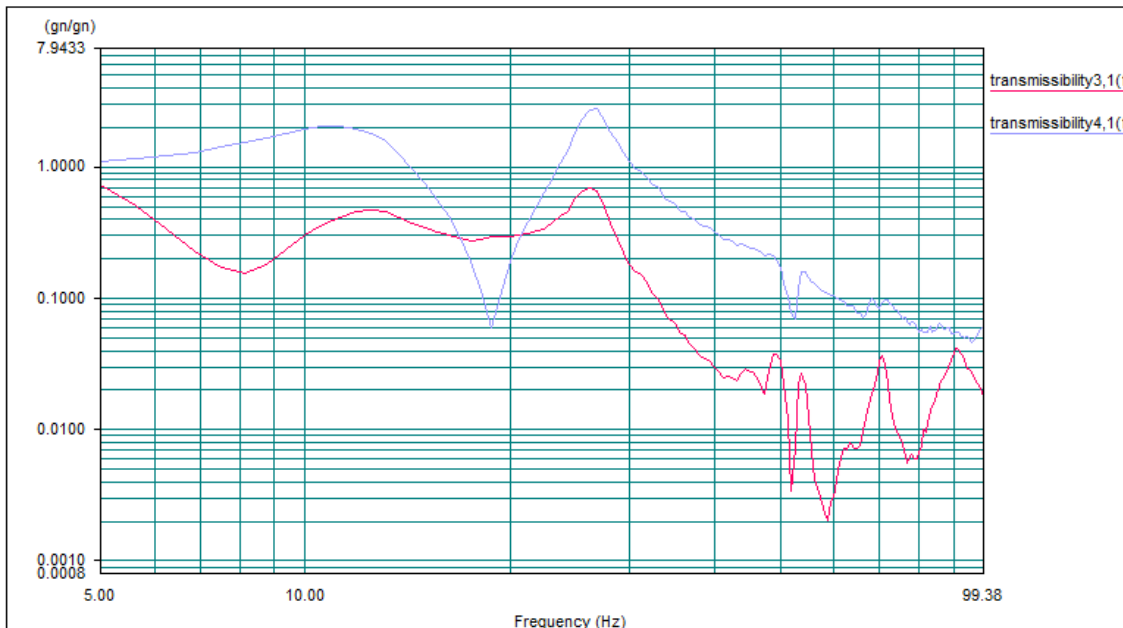
Figure 11: Test B Rail - Transmissibility measurement, input 3 and 4 transversal X

Figure 12: Test B Rail - Transmissibility measurement, input 3 and 4 vertical Z

Figure 13: Test B Rail - Transmissibility measurement, input 3 and 4 longitudinal Y

One test item has been used for the random vibration test which was carried out in the three mutually perpendicular directions, see Table 7 for the result summary. See Figure #10 for a typical vibration plot. See Figure #11 to #13 for the transmissibility measurements of accelerometer response channels 3 and 4. The natural frequency ( $F_n$ ) of the test item was identified at 7Hz, damping started to occur at 10Hz. No visual damage or functional errors were found on the test item after the complete test sequence.

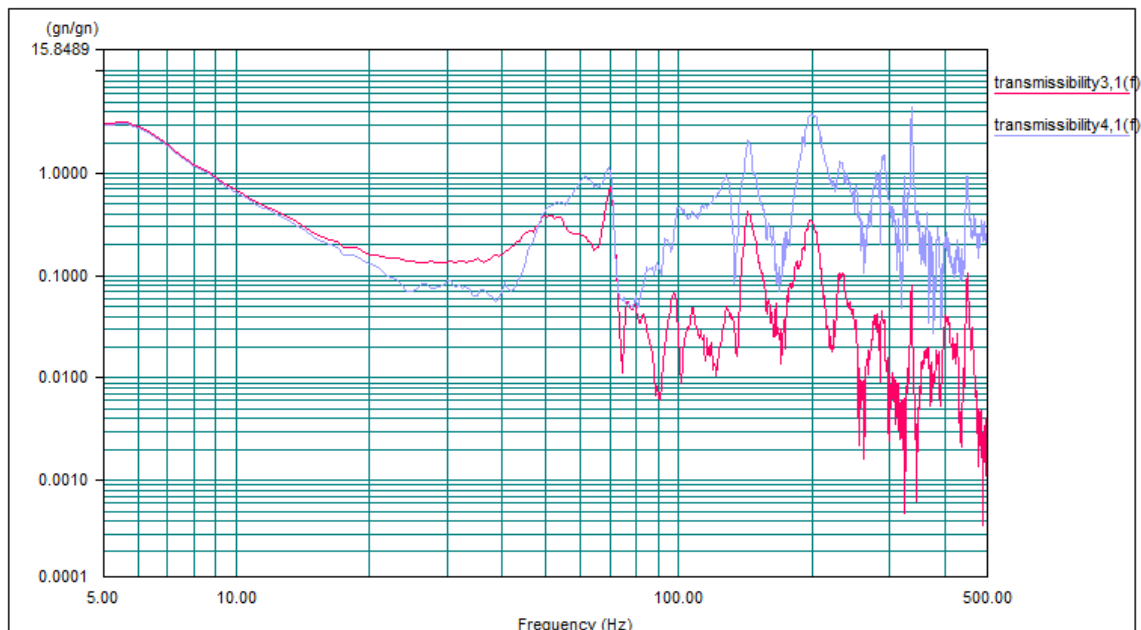
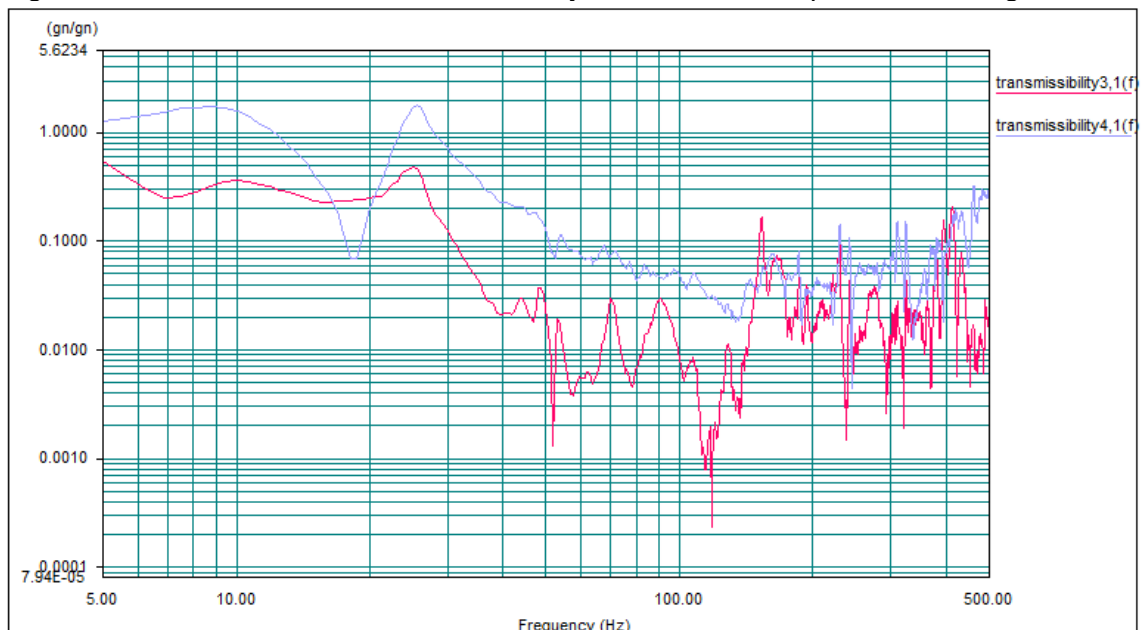
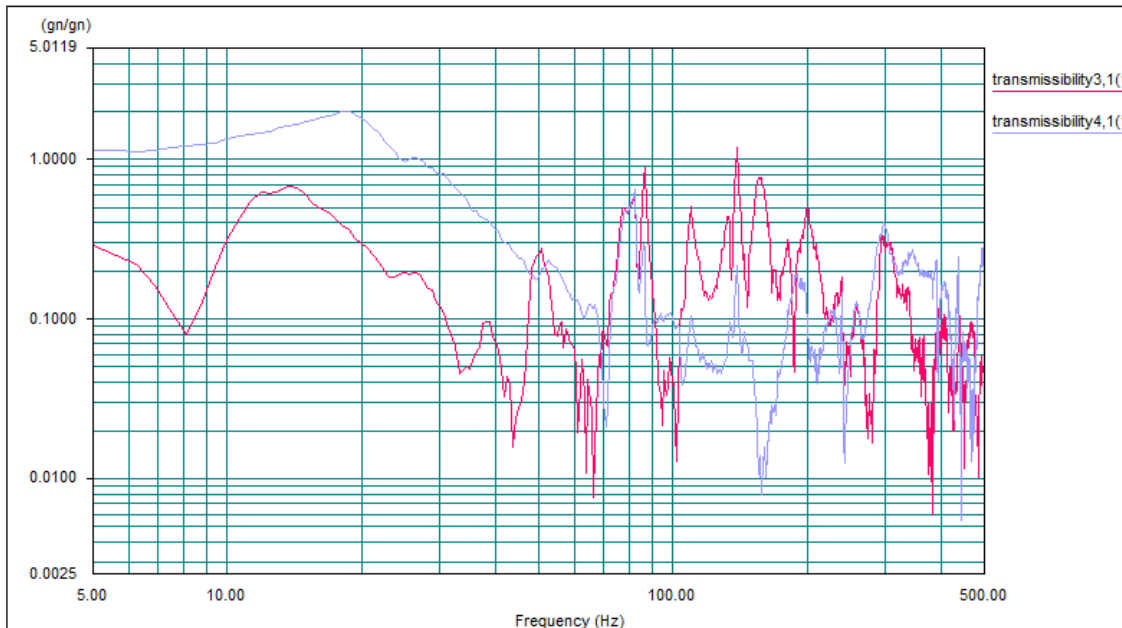
Figure 15: Test C - C.Carrier Transmissibility measurement, input 3 and 4 vertical Z

Figure 16: Test C - C.Carrier Transmissibility measurement, input 3 and 4 longitudinal Y

Figure 17: Test C - C.Carrier Transmissibility measurement, input 3 and 4 transversal X

One test item has been used for the random vibration test which was carried out in the three mutually perpendicular directions, see Table 8 for the result summary. See Figure #14 for a typical vibration plot, see Figure #15 to #17 for the transmissibility measurements of accelerometer response channels 3 and 4. The natural frequency ( $F_n$ ) of the test item was identified at 6Hz, damping started to at 8,5Hz. No visual damage or functional errors were found on the test item after the complete test sequence.

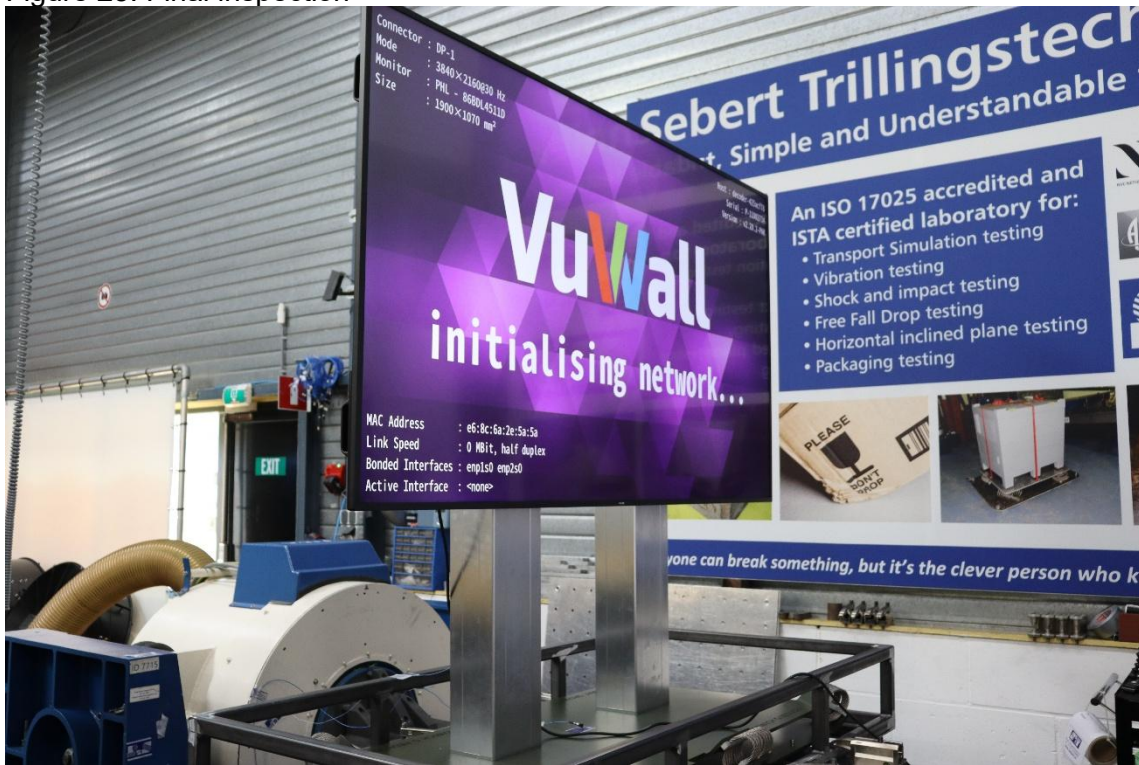
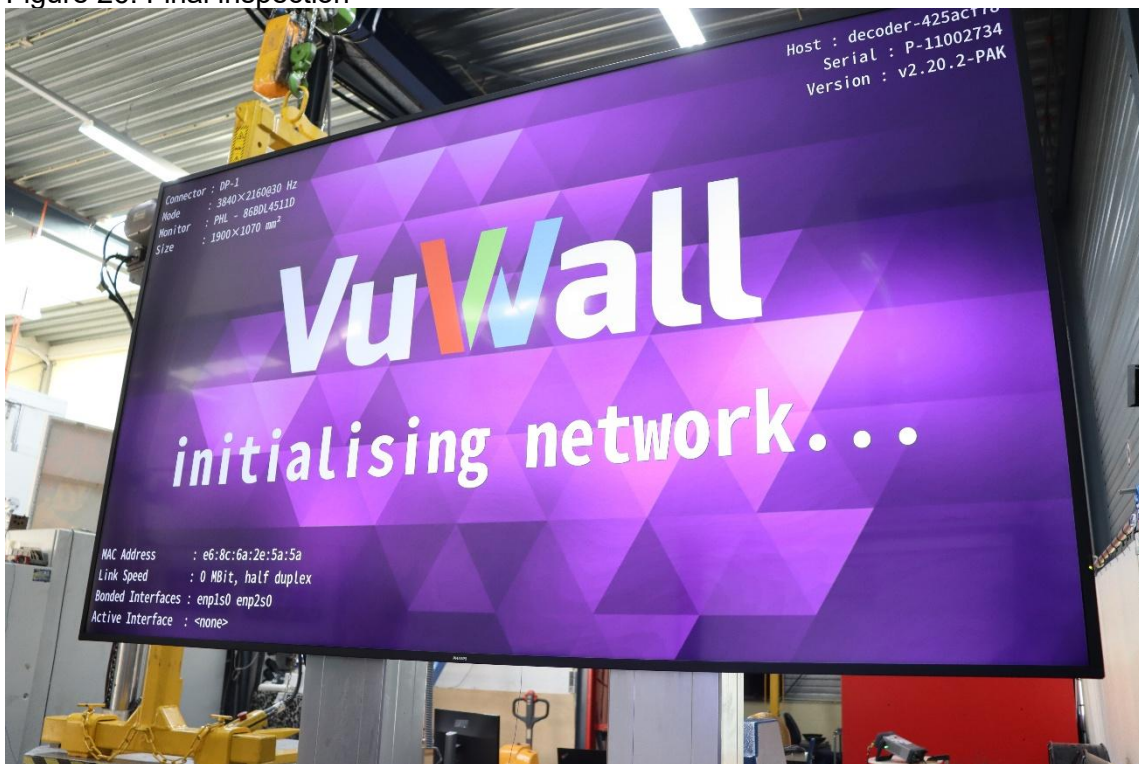
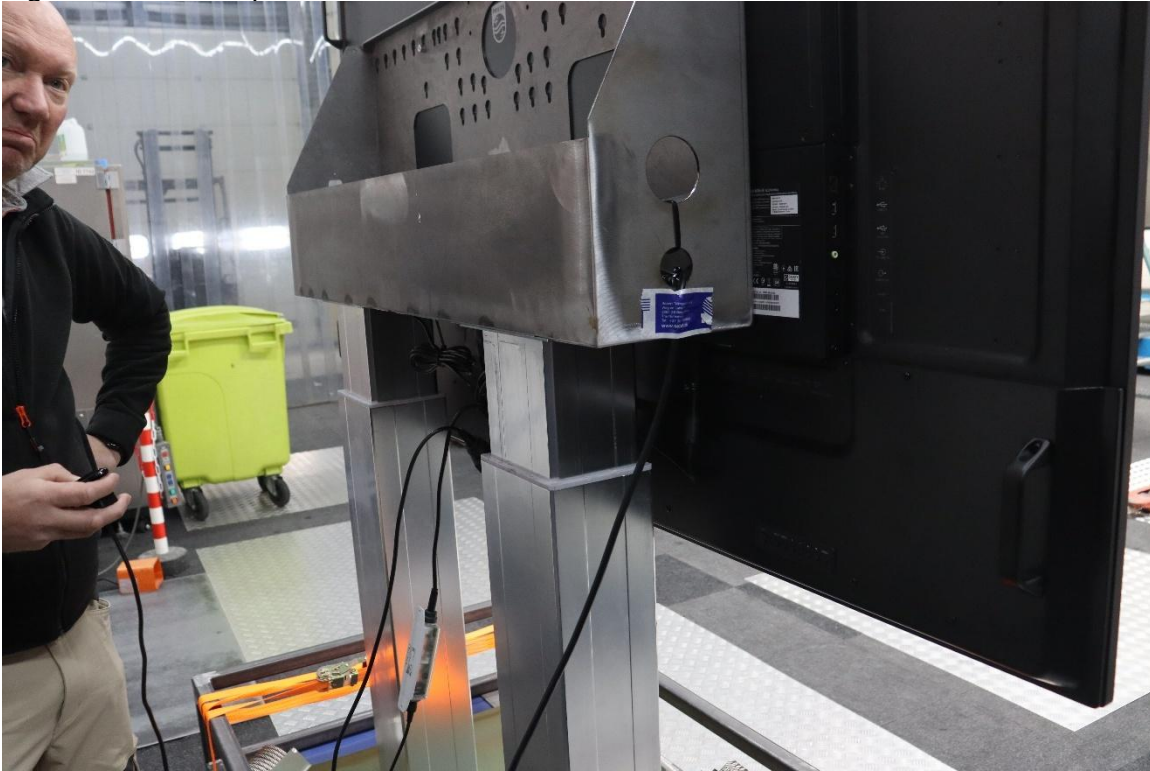
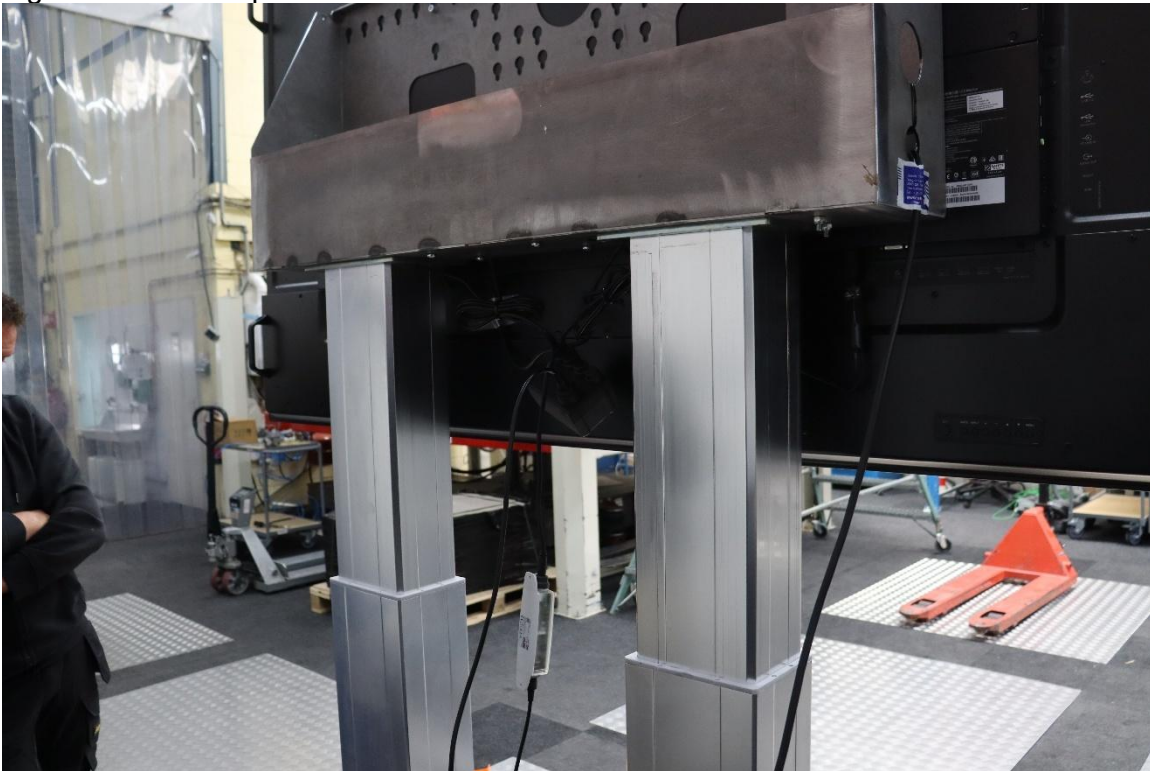
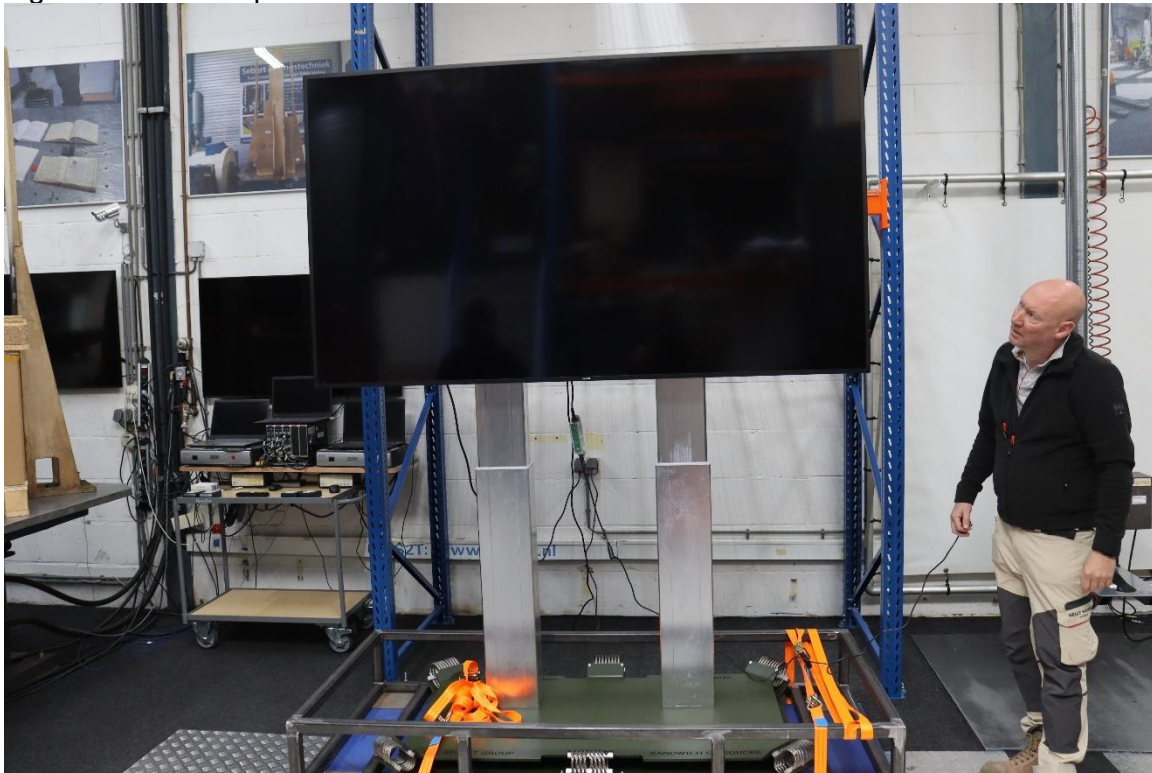
Figure 25: Final inspection

Figure 26: Final inspection

Figure 27: Final inspection

Figure 28: Final inspection

Figure 29: Final inspection

Test item	Results and/or remarks	Figure
#1	After all testing had been completed, the display was able to be powered on without error. The display was also able to be raised and lowered by the motorized extendable feet without error.	#25 #29

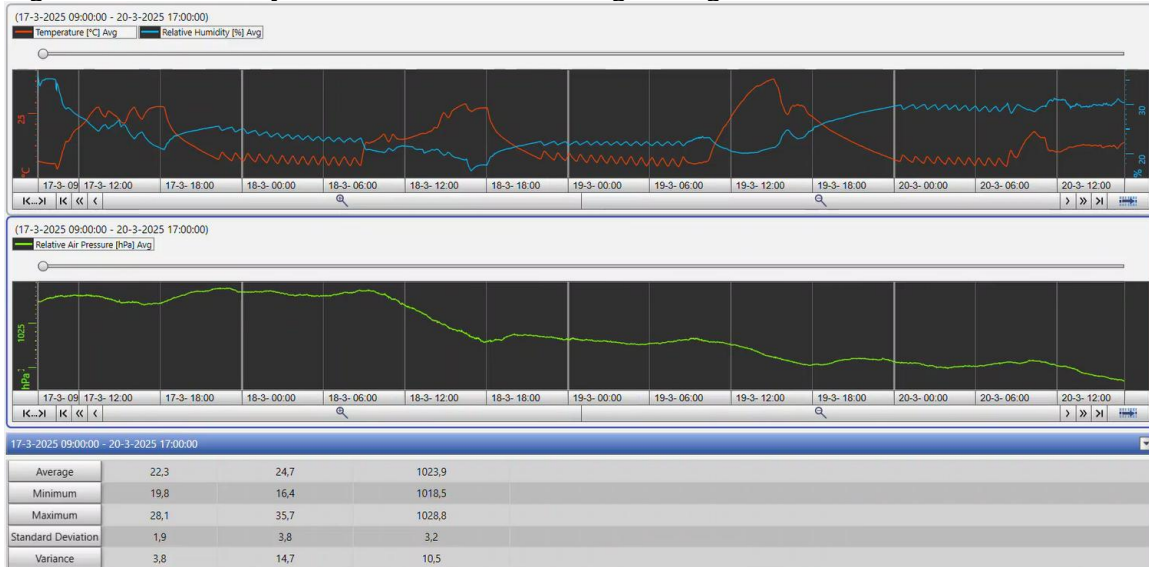
Figure 30: Laboratory ambient conditions during testing

See Figure #30 for the environmental measurements during the test sequence.
