Report: M25.001-P25.001 One Display Solution
Date 26 March 2025

MIL-STD 810/AECTP 400 Random Vibration and Terminal Peak Sawtooth Shock Tests on a PSM-P86RV1

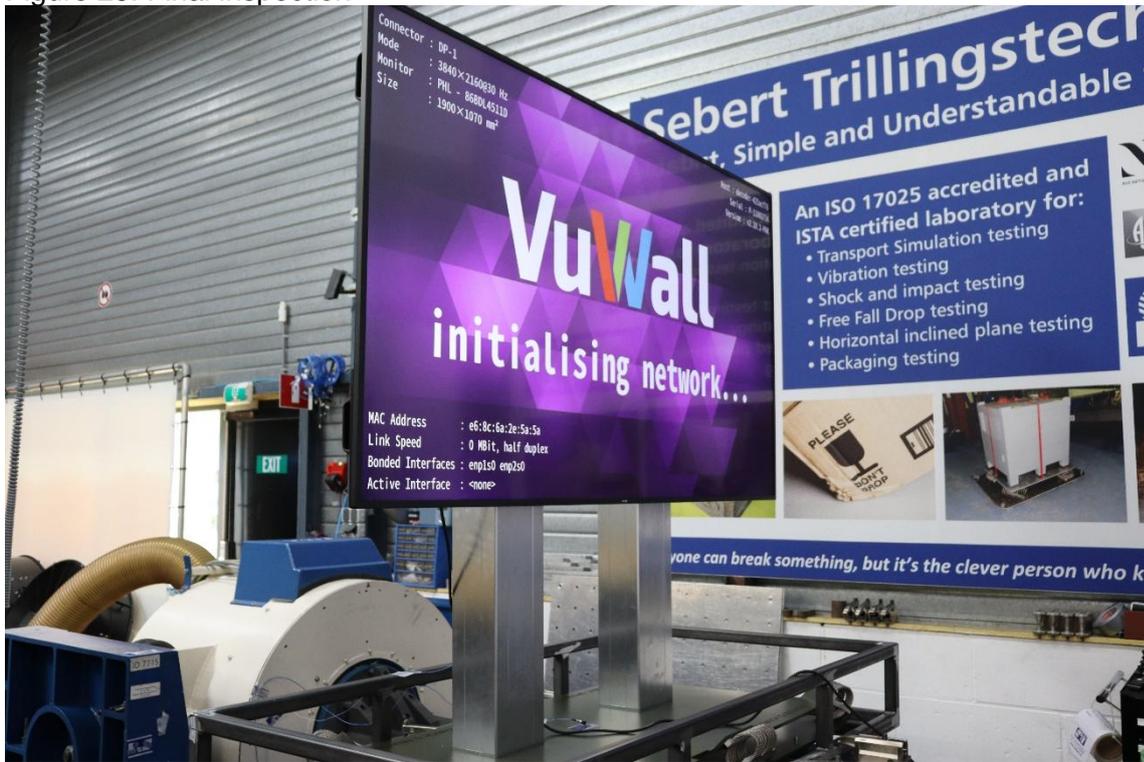
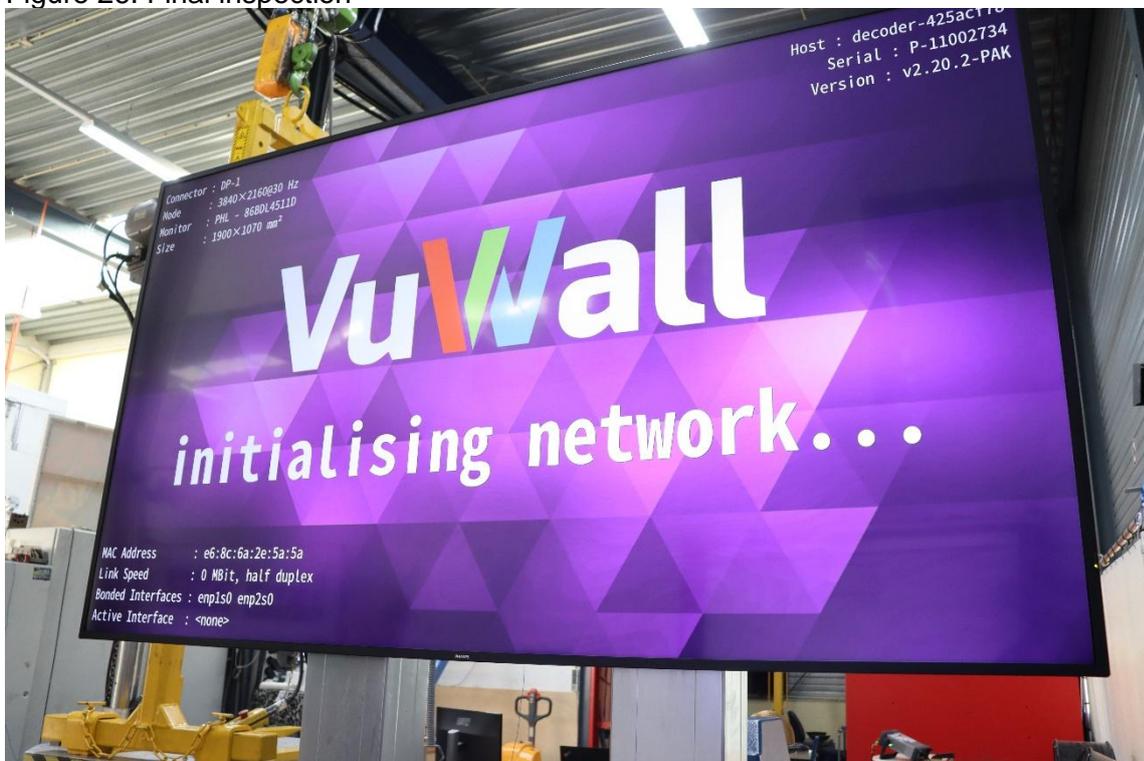
Test item	Results and/or remarks	Figure
#1	After all testing had been completed, the display was able to be powered on without error. The display was also able to be raised and lowered by the motorized extendable feet without error.	#25 #29

Figure 25: Final inspection
